Manhole Inspection Summary

Manhole # S45UU_029MH

Insp Date: **2/7/07 2:00 PM**

Location Address: **2728 FENWICK AVE**

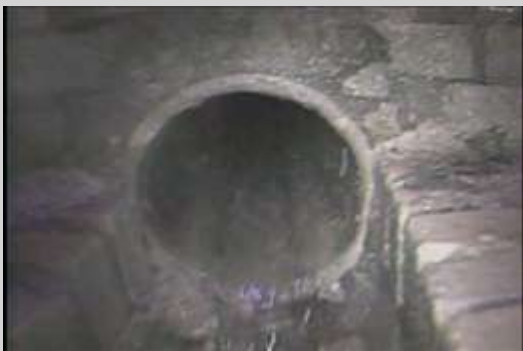
Pipe In @ 3 O'Clock

8 in. Circular Gravity Sewer

Pipe Material: **Clay** ☐ Pipe Lined

Infiltration: **None** Pipe Seal Cond: **Unknown**
